29. THE ACCIDENT

30. DAMAGE TO THE AIRCRAFT

31. THE INVESTIGATION

32. THE ANALYSIS

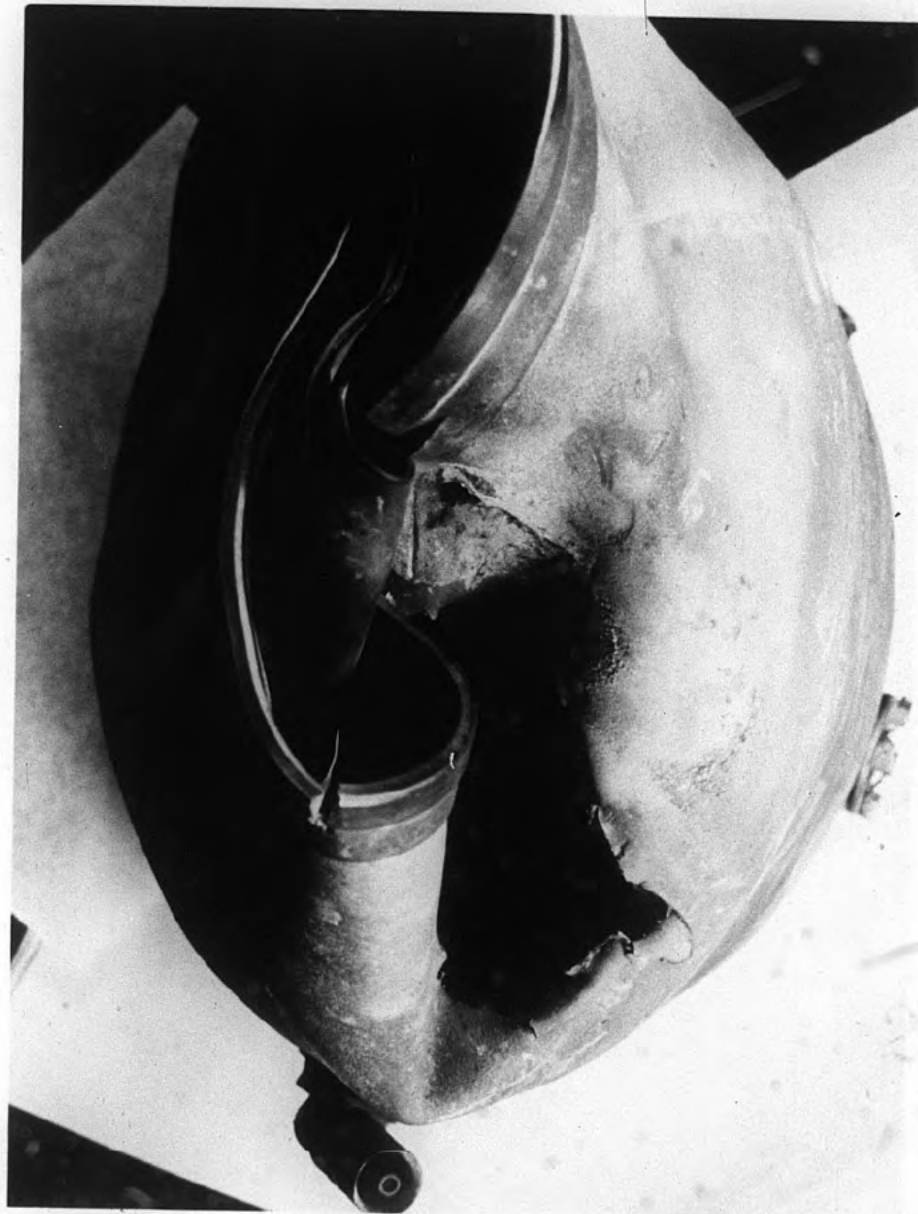
ENCLOSURE (10)-1

The number three (3) combustion chamber was submitted to NIS, North Island O & R Laboratory for an analysis to determine if conclusive evidence could be obtained that a 20MM round did penetrate the chamber. The laboratory analysis is forwarded as enclosure 16. The laboratory findings were; that an object partially composed of a copper bearing alloy caused the penetration of the number three (3) combustion chamber.

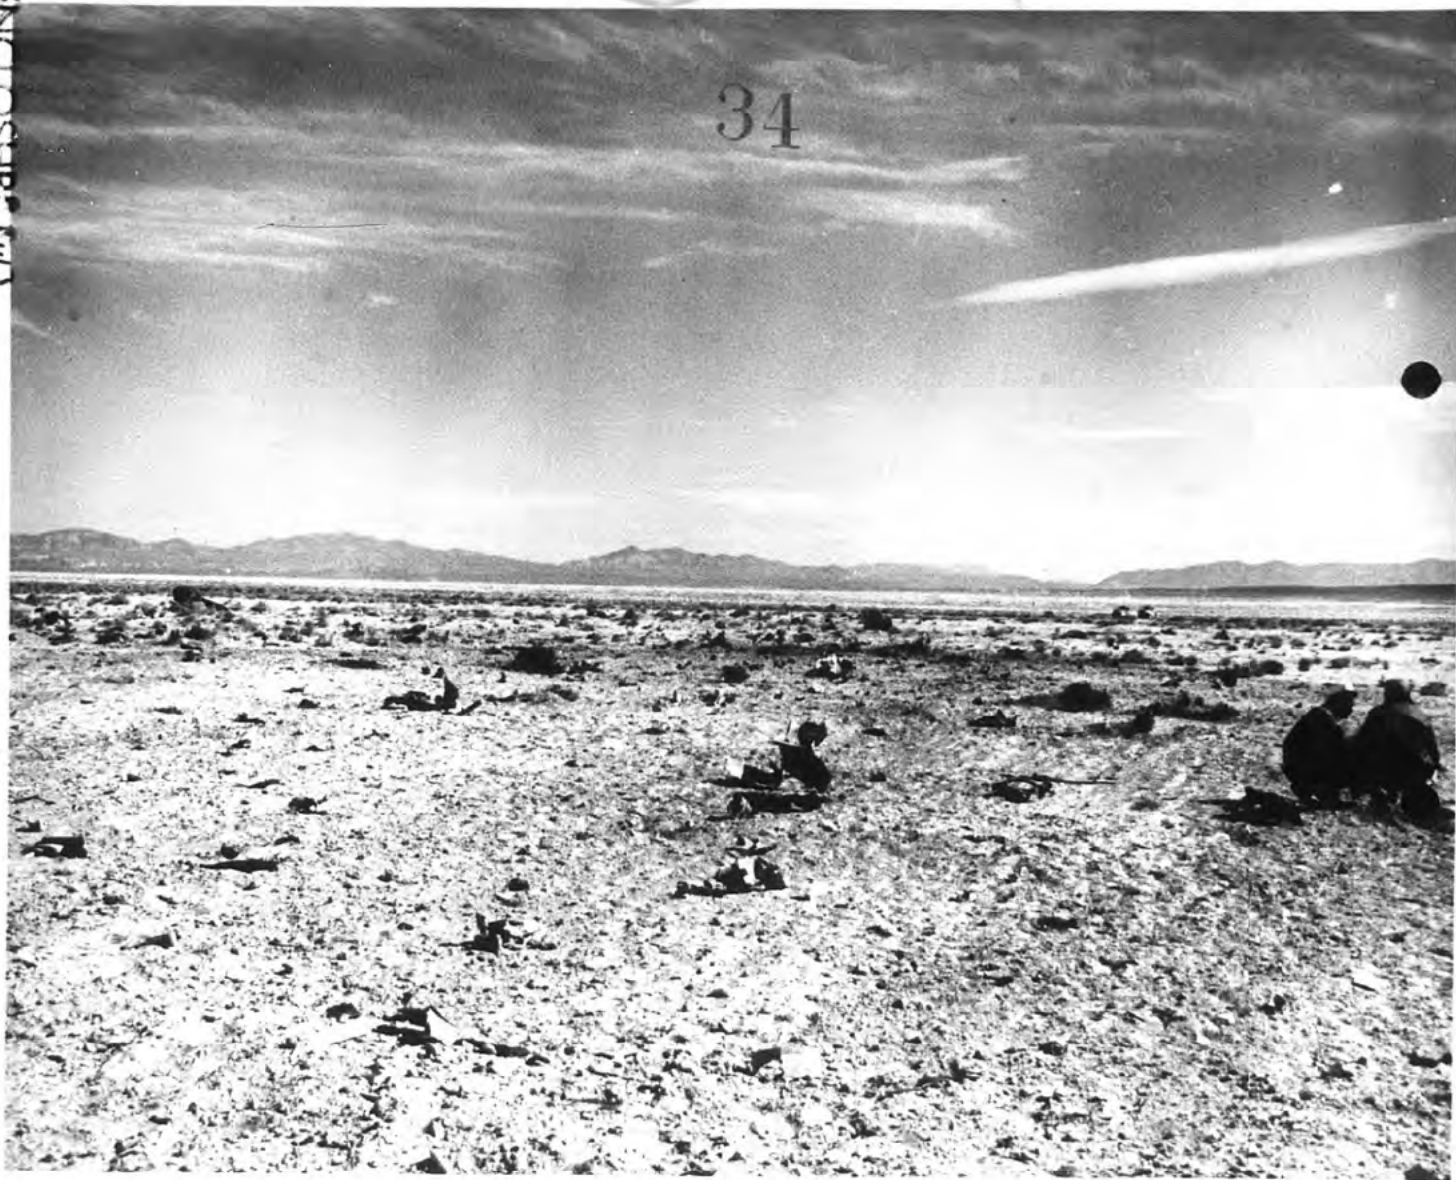
ENCLOSURE 15

The aircraft crashed about 130 miles from NAAS, Fallon, in a nearly inaccessible area of the Black Mountain gunnery range. The Board members reached the scene of the accident about noon Saturday, 2 October 1954. The aircraft was identified by the bureau number, 123509, painted on the tail section (See enclosure 15).

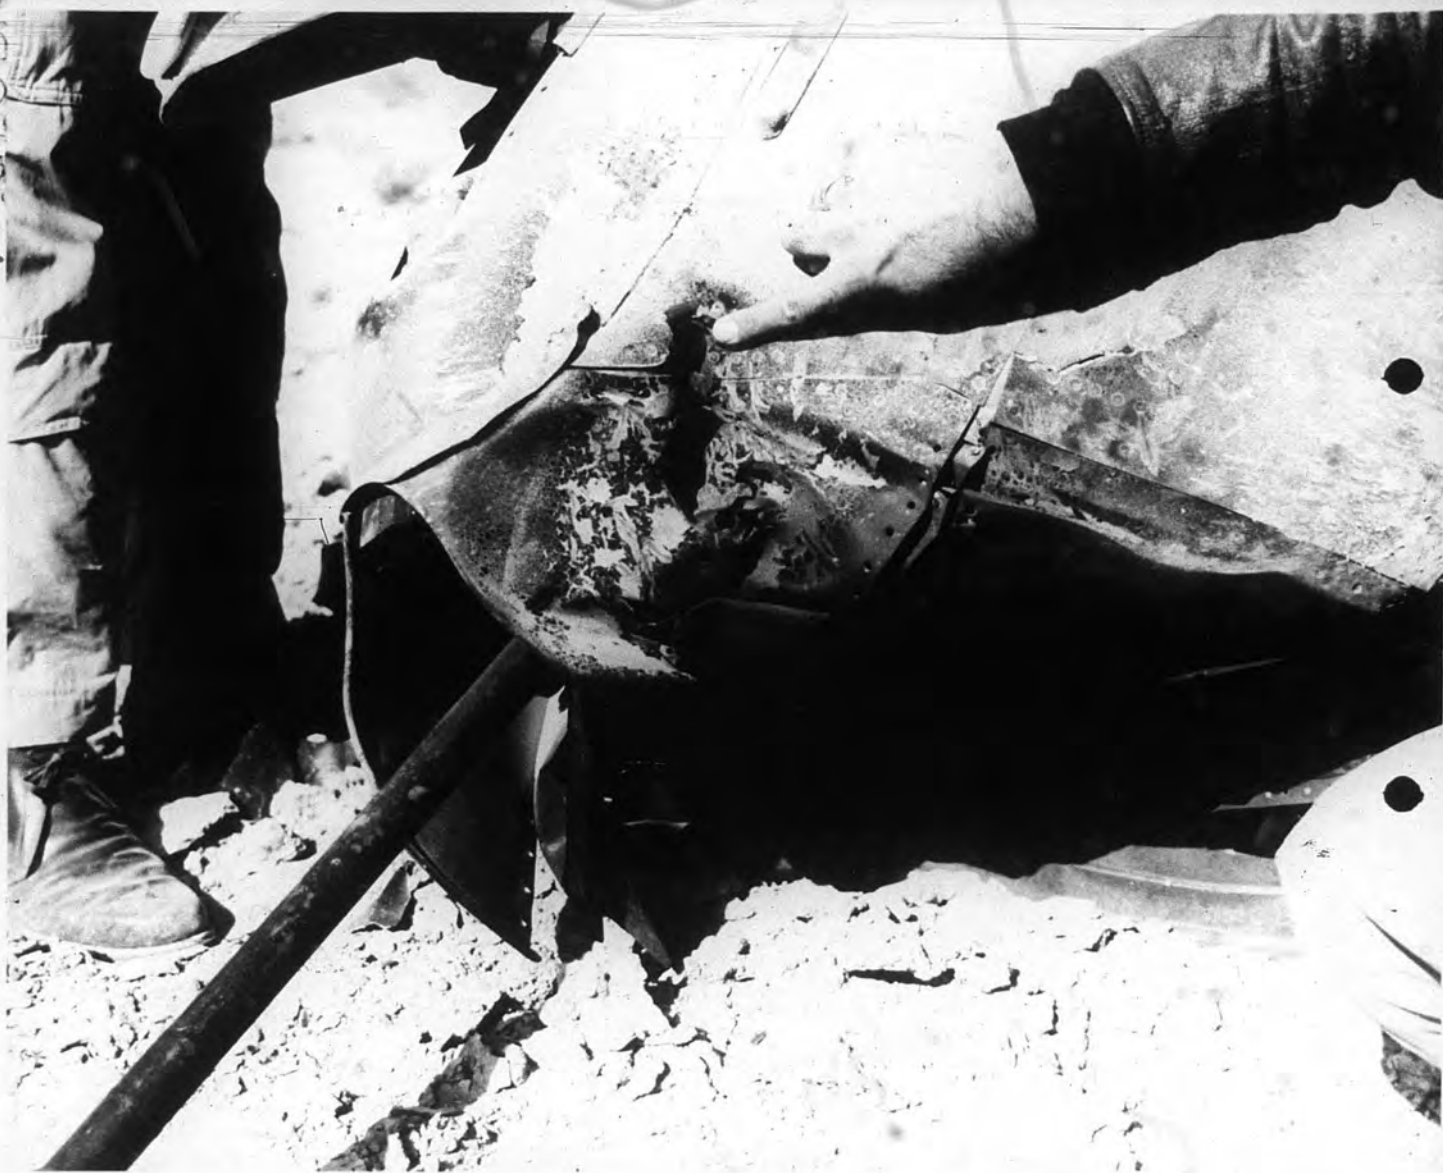
ENCLOSURE (149)

All parts in the area were examined by the board for possible contribution to the accident. Inasmuch as most parts were charred, bent or broken, identification was quite difficult. The number three (3) combustion chamber was recovered. (See enclosure 19). It appears to have been penetrated by a projectile about the size of a 20MM shell. The direction of entry and exit corresponds to that of a projectile being fired from astern and slightly from the starboard side of the tow aircraft. Upon exiting from the combustion chamber, the projectile probably caused shrapnel from the chamber cover to enter into the turbine.
